NASA CR-121157
AI-73-31

FINAL REPORT
S8DR SHIELD EXAMINATION

ATOMICS INTERNATIONAL DIVISION
ROCKWELL INTERNATIONAL CORPORATION

NASA Lewis Research Center
Contract NAS 3-15705
L. Kaszubinski, Project Manager

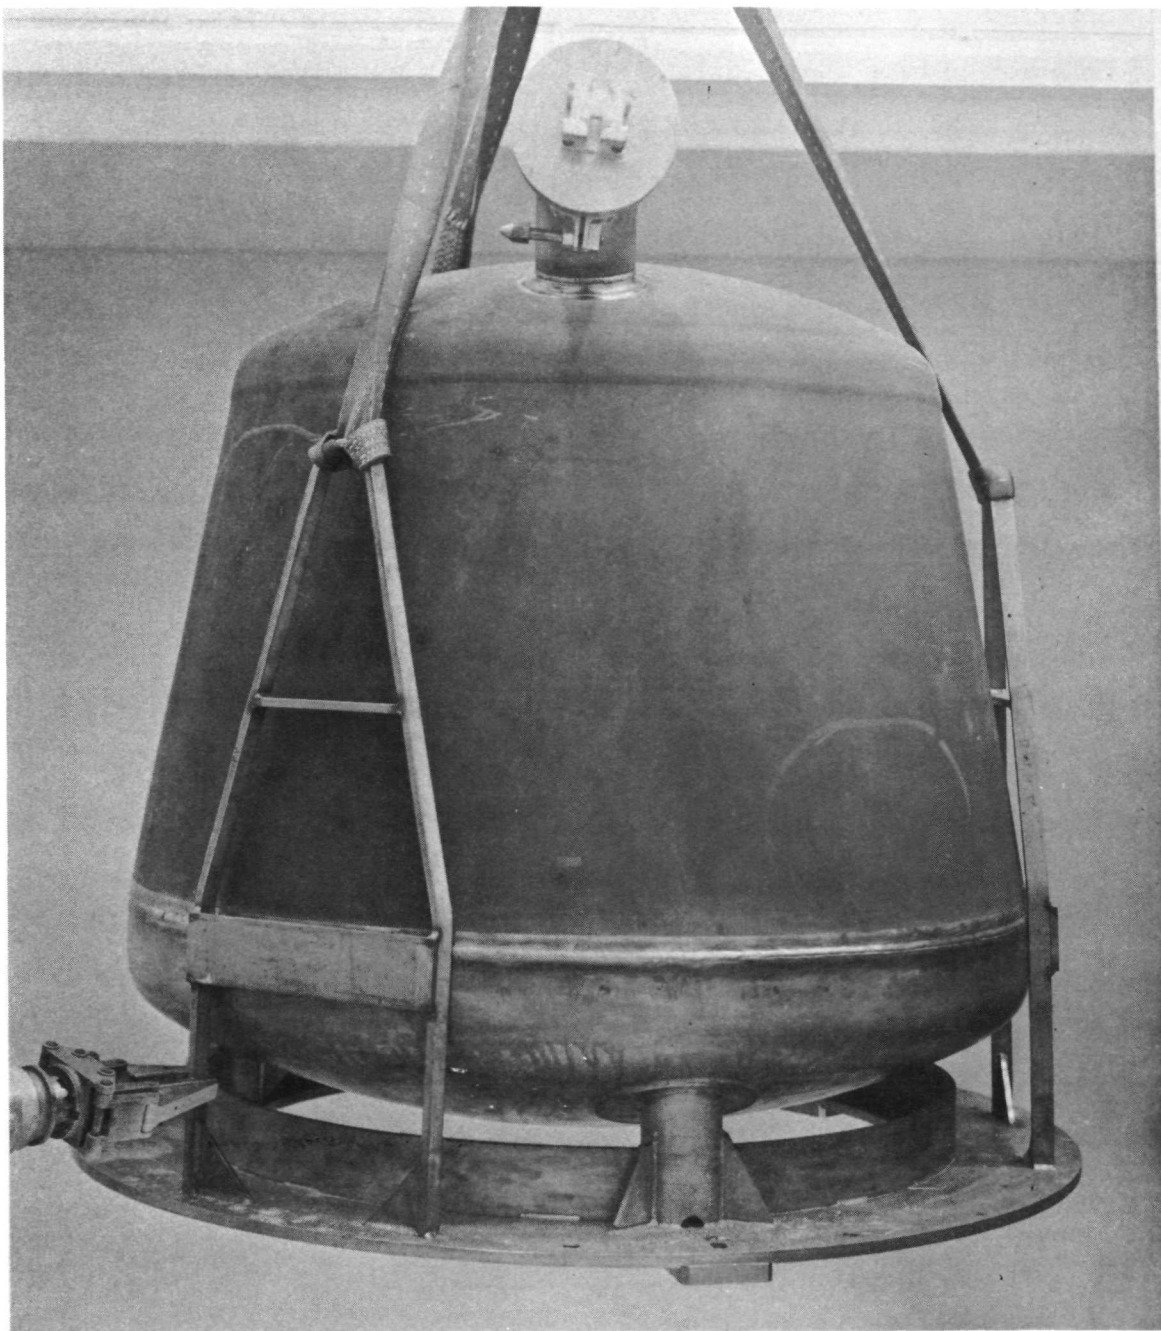
Figure 1 - DR106. Lithium Hydride Shield as received, at 0°.

The shield was shipped from the Radioactive Materials Disposal Facility (RMDF) to the Atomics International Hot Laboratory (AIHL) and unloaded into Cell #4 on April 10, 1972. Photographs were taken of the shield as received on four orientations through the cell window. The appearance of the shield was excellent (Figure 1).

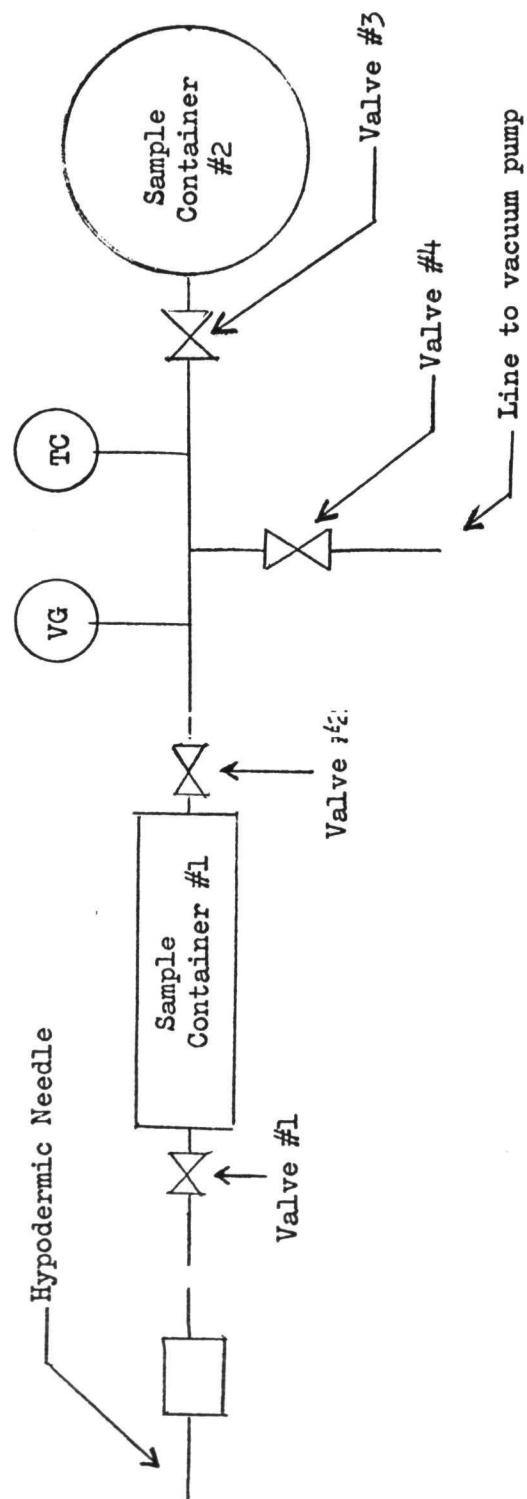
Figure 2

The gas contained in the confinement space between the shield and the confinement vessel was sampled. Refer to the schematic (Figure 2) for the following description of the gas sampling. A 1/4 inch hole was drilled through the aluminum cap cover on the 4.5 inch pipe. A hypodermic needle attached to two gas sample containers was pushed about 1/4 inch into the rubber cap gasket so the hole in the needle would be sealed. The sample containers and line to the needle were evacuated to less than 1 micron. The sample containers were isolated from the vacuum

GAS SAMPLING SCHEMATIC

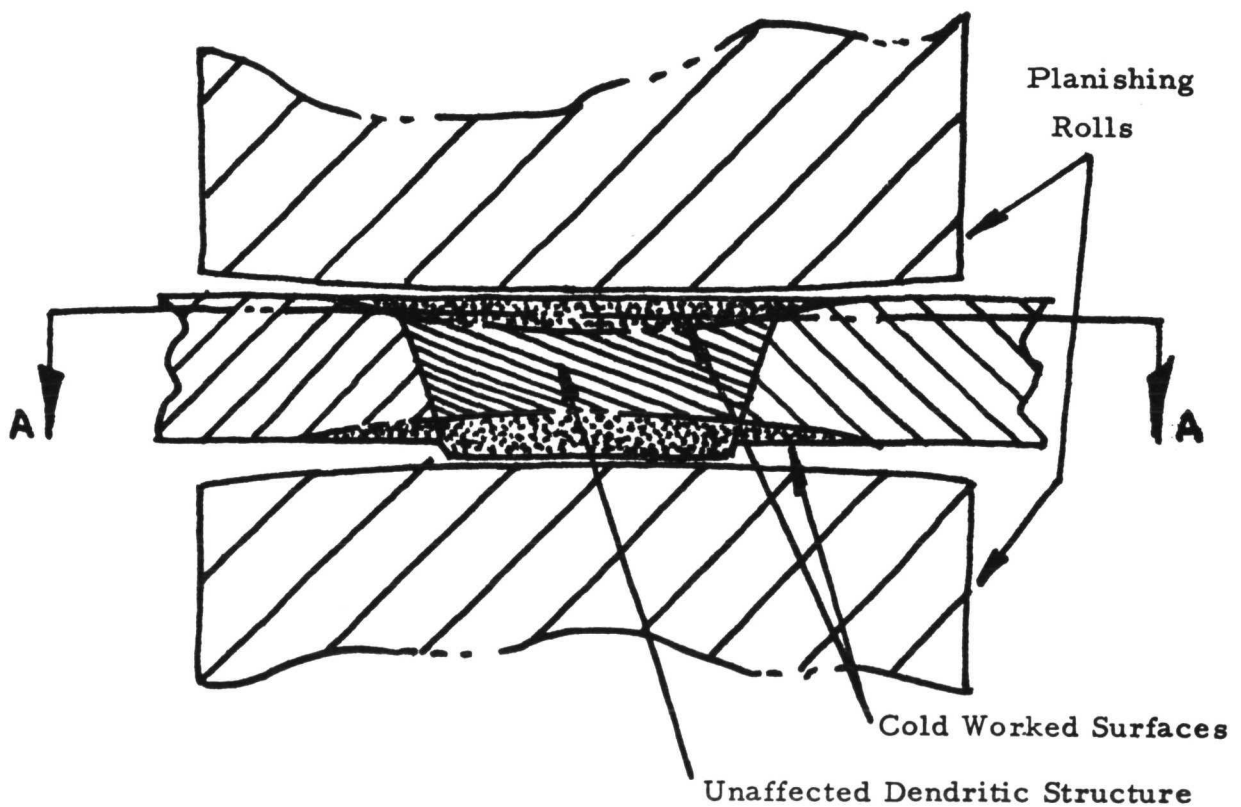
Figure 3
Enlargement of Same View Shown in Figure 1

Examination of the metallographic mount showed that the crack was intergranular and appeared to initiate at a small discontinuity at the approximate center of the weld (figures 3 and 4). It was also noted that the dendritic structure was distorted, apparently a result of planishing, and did not follow

a normal semi-circular or triangular freezing pattern (figures 1 and 3). There were islands of what initially appeared as equiaxed grain structure observed in the fusion zone (figures 1, 3, and 4). This was considered abnormal for the weld involved and was later interpreted as recrystallized cold-worked material (see discussion). The structure was essentially all-austenitic with virtually no delta ferrite visible (figure 4). This conclusion was reached by comparing the viewed structures with weld structures known to contain specific delta ferrite contents.⁽⁴⁾ The dendritic formations (other than being distorted) were generally long, narrow, and almost perpendicular to the direction of rolling (figures 1 and 3). There was no evidence of sigma phase.

A-A represents top view metallographic mount shown in Figure 1.

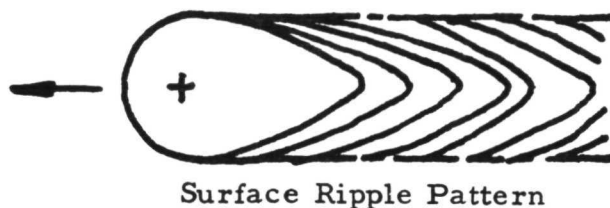
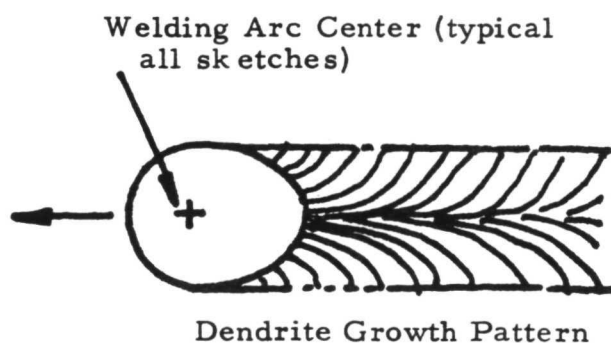
A. Triangular Pattern. The tear drop shape is associated with high speed, center-bead segregation, and center-bead cracking. This was typical of the weld examined in this investigation.

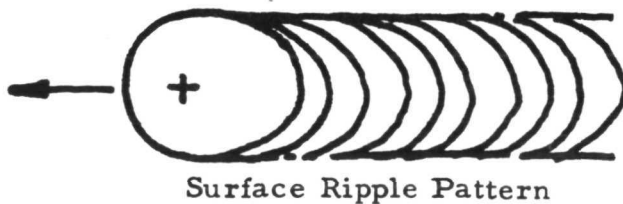
B. Semicircular Pattern. The elliptical shape is associated with lower speed, reduced localized segregation, and reduced fissuring in hot short alloys.

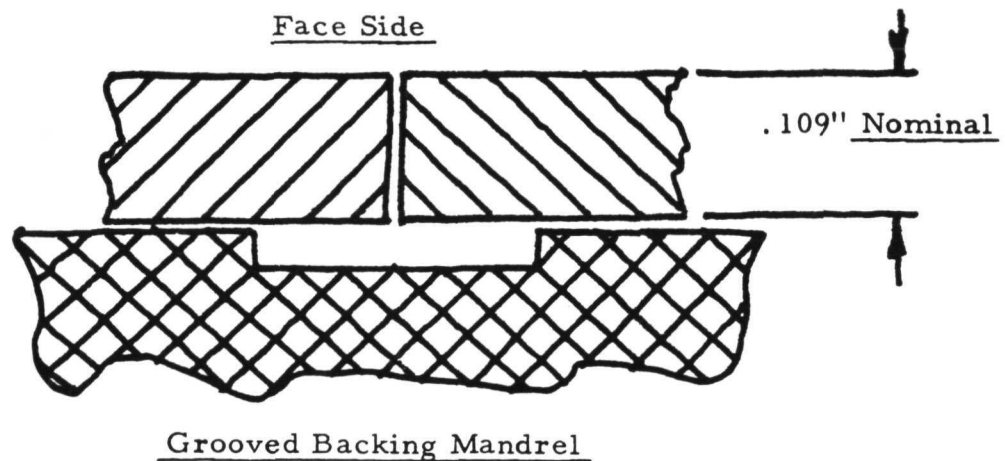
A. Probable Weld Joint Preparation

conventionally utilizes a grooved backing mandrel--usually copper (figure 6A). The molten nugget is literally "cast" into this groove deliberately to result in minimal drop-through of uniform dimensions and a weld face exhibiting some amount of uniform concavity (figure 6B). This cross-section may be much easier to planish flat, but may not achieve the objectives for planishing mentioned earlier.
